EVALUATION OF HYDROLOGIC PROCESSES AFFECTING SOIL MOVEMENT IN THE HAGERMAN FAUNA AREA, HAGERMAN, IDAHO

Water-Resources Investigations Report 84-4137

By H. W. Young

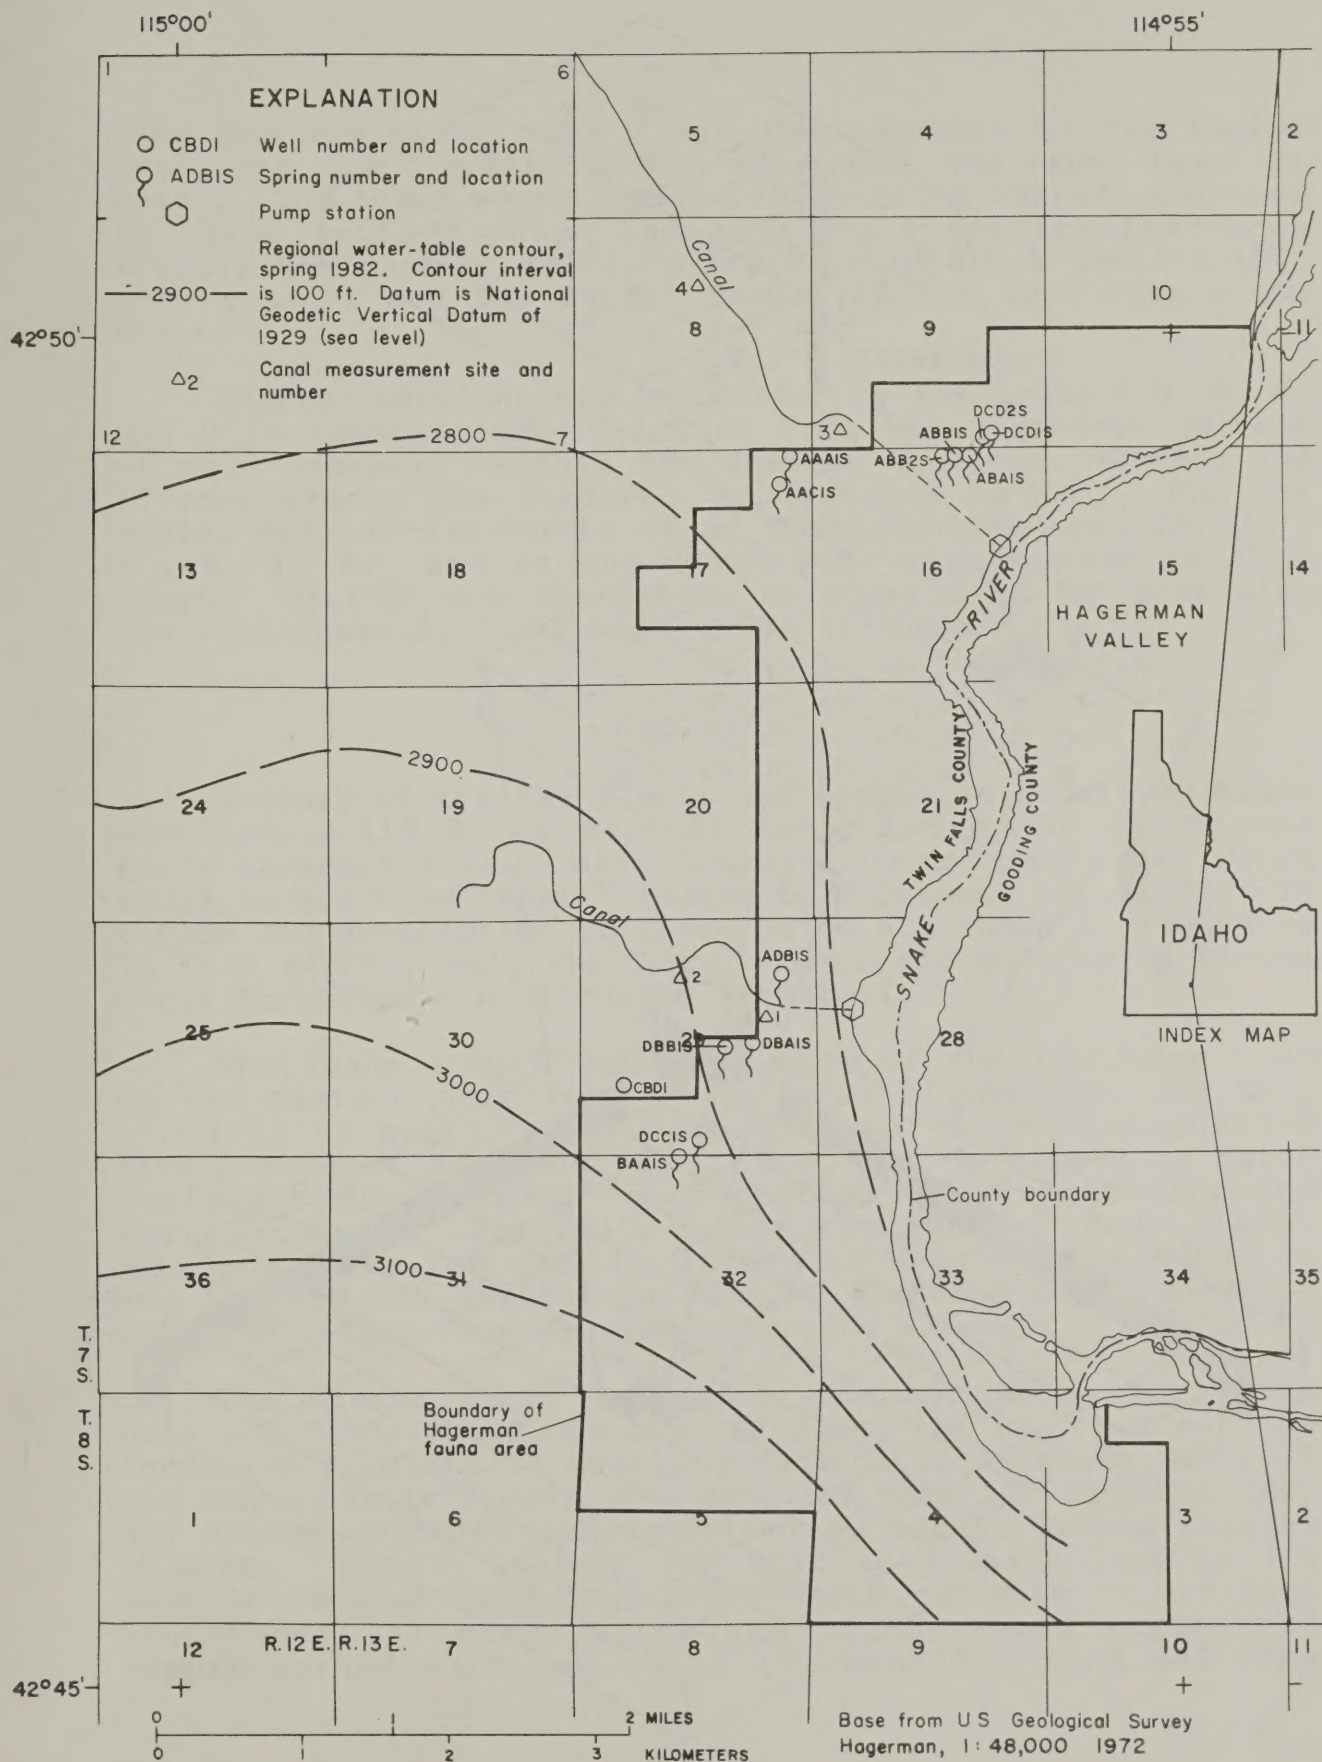
Figure 1.--Regional water-table contours and locations of data-collection sites.

Water-table contours for the regional aquifer system in the vicinity of the fauna area are shown in figure 1. Altitude of the water table in the regional aquifer ranges from about 2,800 to 2,900 ft above sea level. The springs discharge at altitudes generally between about 3,100 and 3,200 ft, which indicates the source of the springs is a minor aquifer perched above the regional water table (fig. 1).

The extent of the perched aquifer is not well defined, and only one well (7S-13E-29CBD1, see fig. 1) is known to be completed in this aquifer. The well is 245 ft deep and, in September 1983, depth to water was about 139 ft. The driller's log indicates that the well is completed in the Glens Ferry Formation. The water-bearing zone is just below the contact with the Tuana Gravel in a sand layer between 150 and 161 ft. The log also indicates that no additional water was encountered during drilling and that most of the remaining material penetrated was fine-grained clay, silt, and sandstone.

Prior to development of farmlands on the plateau and construction of two irrigation canals supplied by water pumped from the Snake River and lifted to the canyon rim (fig. 1), the springs and seeps on the canyon slope did not exist. Therefore, the principal source of recharge to the perched aquifer that feeds the springs and seeps is probably seepage losses from the canals. Other possible sources of recharge include infiltration of applied irrigation water and precipitation.

Streamflow measurements along the irrigation canals are given below (see fig. 1 for locations of measuring sites):

<u>Site No.</u>	<u>Discharge, in cubic feet per second</u>
1	52.1
2	50.4
Estimated loss per mile is 3.3 ft ³ /s, or 6 percent	
3	71.5
4	66.9
Estimated loss per mile is 4.6 ft ³ /s, or 6 percent

Assuming a 120-day irrigation season, annual canal losses for a 1-mi reach near the fauna area total about 1,900 acre-ft.

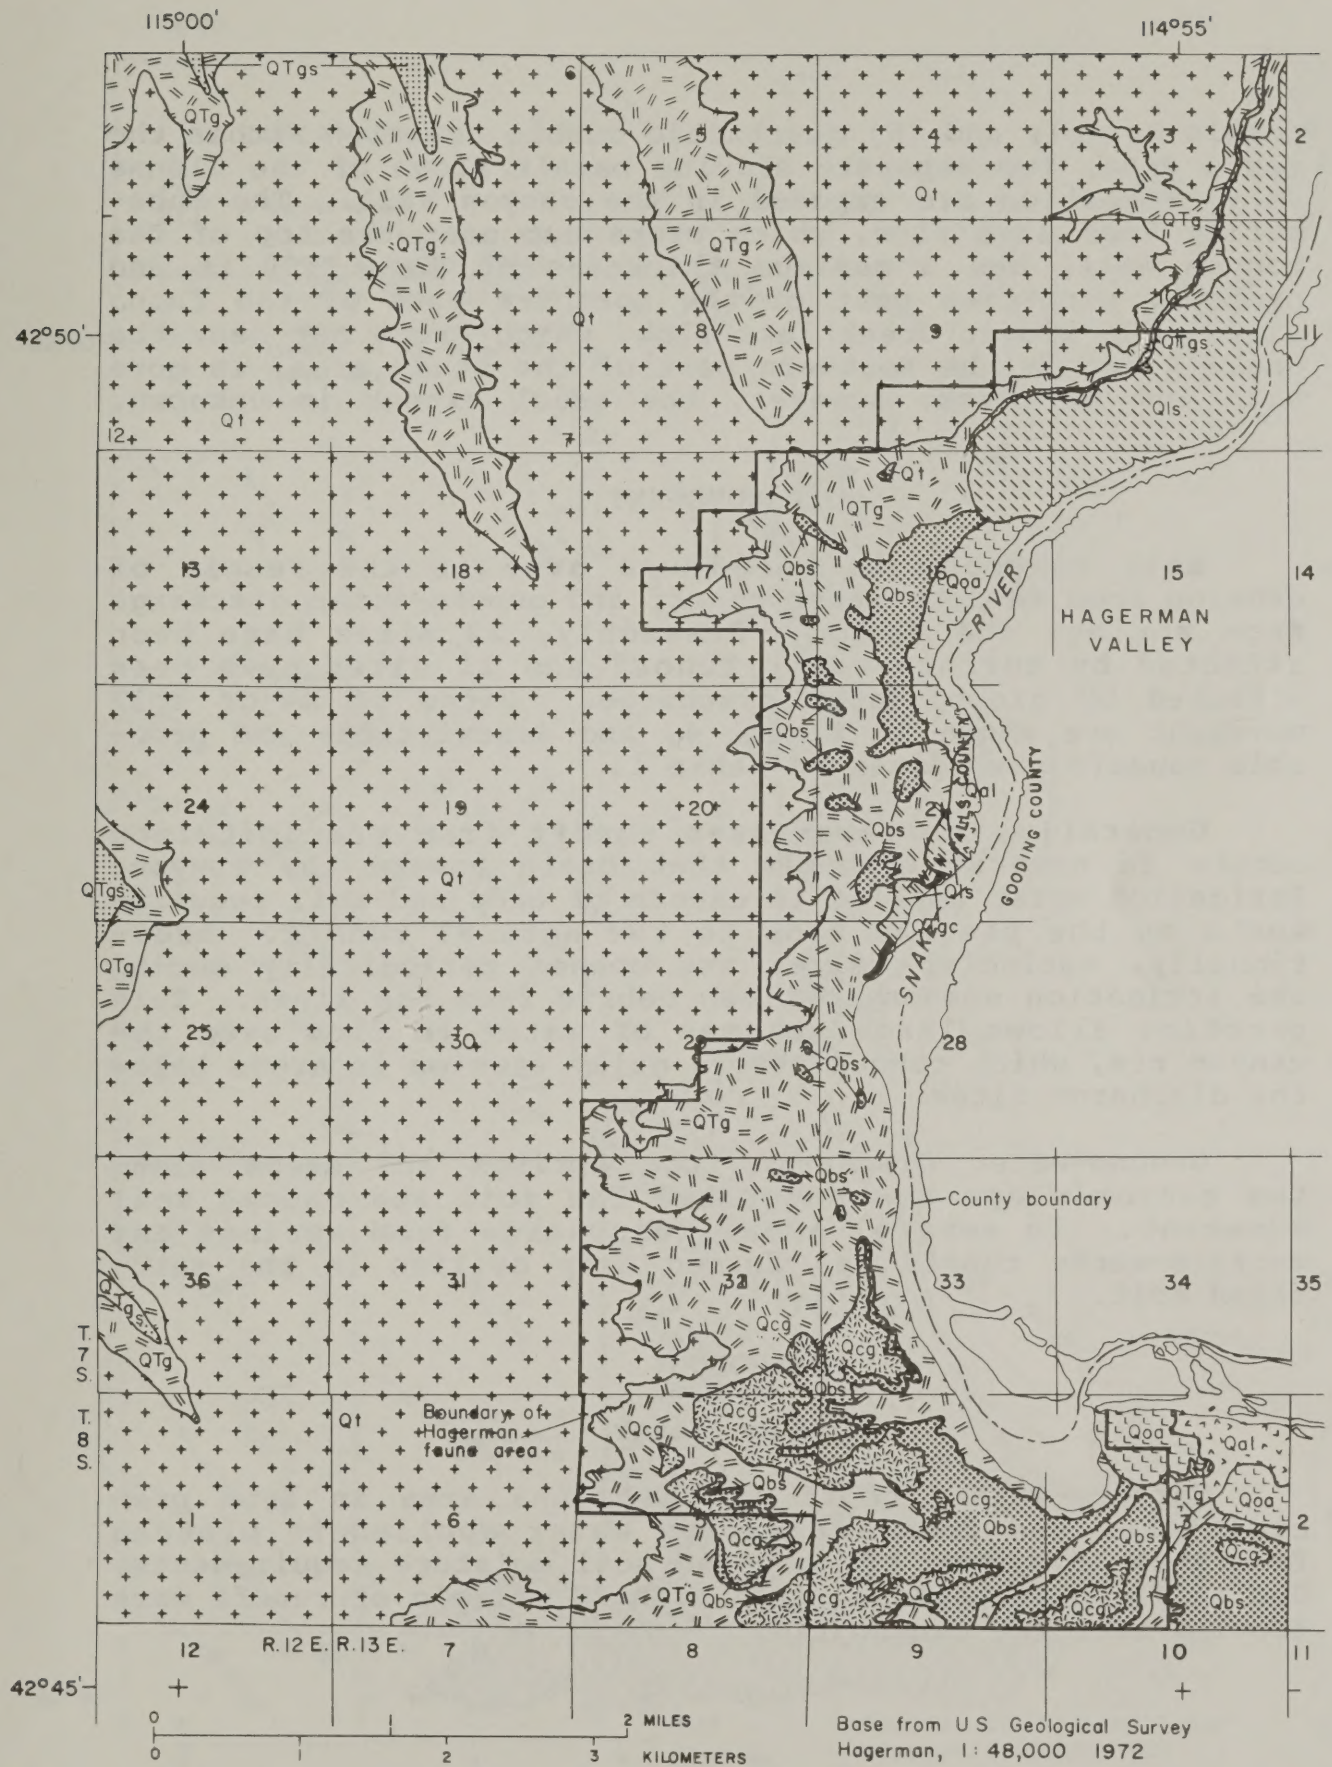
Figure 3.--Geology of the

Geology of the fauna area was mapped in detail by Malde and Powers (1972) as part of their survey of the Glenns Ferry-Hagerman area. Nine geologic units are mapped which range in age from upper Pliocene to Holocene. Areal distribution and description of these units are shown in figure 3. In this report, only the Tuana Gravel and underlying Glenns Ferry Formation are discussed in detail.

The Tuana Gravel underlies most of the irrigated land on the plateau above the fauna area. Generally, the unit consists of pebble- and cobble-sized gravel interbedded with layers of sand and silt. The unit is capped by dense caliche. The caliche layer probably restricts downward percolation of irrigation water applied on the plateau. However, where the caliche layer has been disrupted, as it has been by two irrigation canals, downward percolation of water is likely (see section on ground water).

The Glenns Ferry Formation, through which the fauna beds are distributed, is exposed along the canyon rim. The formation consists of poorly consolidated detrital material and minor basalt flows. The detrital material includes lake and stream deposits characterized by abrupt lateral facies changes. Facies include (1) silt in massive layers; (2) sand in layered beds that are locally cemented to a flaggy sandstone; (3) clay, silt, and carbonaceous shale; (4) ripple-marked sand and silt; (5) granitic sand and fine

pebble gravel; and (6) quartzitic cobble gravel. Within the fauna area, two separate olivine basalt flows of the Glenns Ferry Formation are exposed in the canyon wall. The Shoe-string Road lava flow, which crops out near the top of the canyon wall, has a maximum thickness of about 100 ft and probably underlies most of the northern part of the fauna area. The Clover Creek lava flow, which crops out near the Snake River in the southern part of the study area, is more than 100 ft thick; however, the areal extent is unknown.

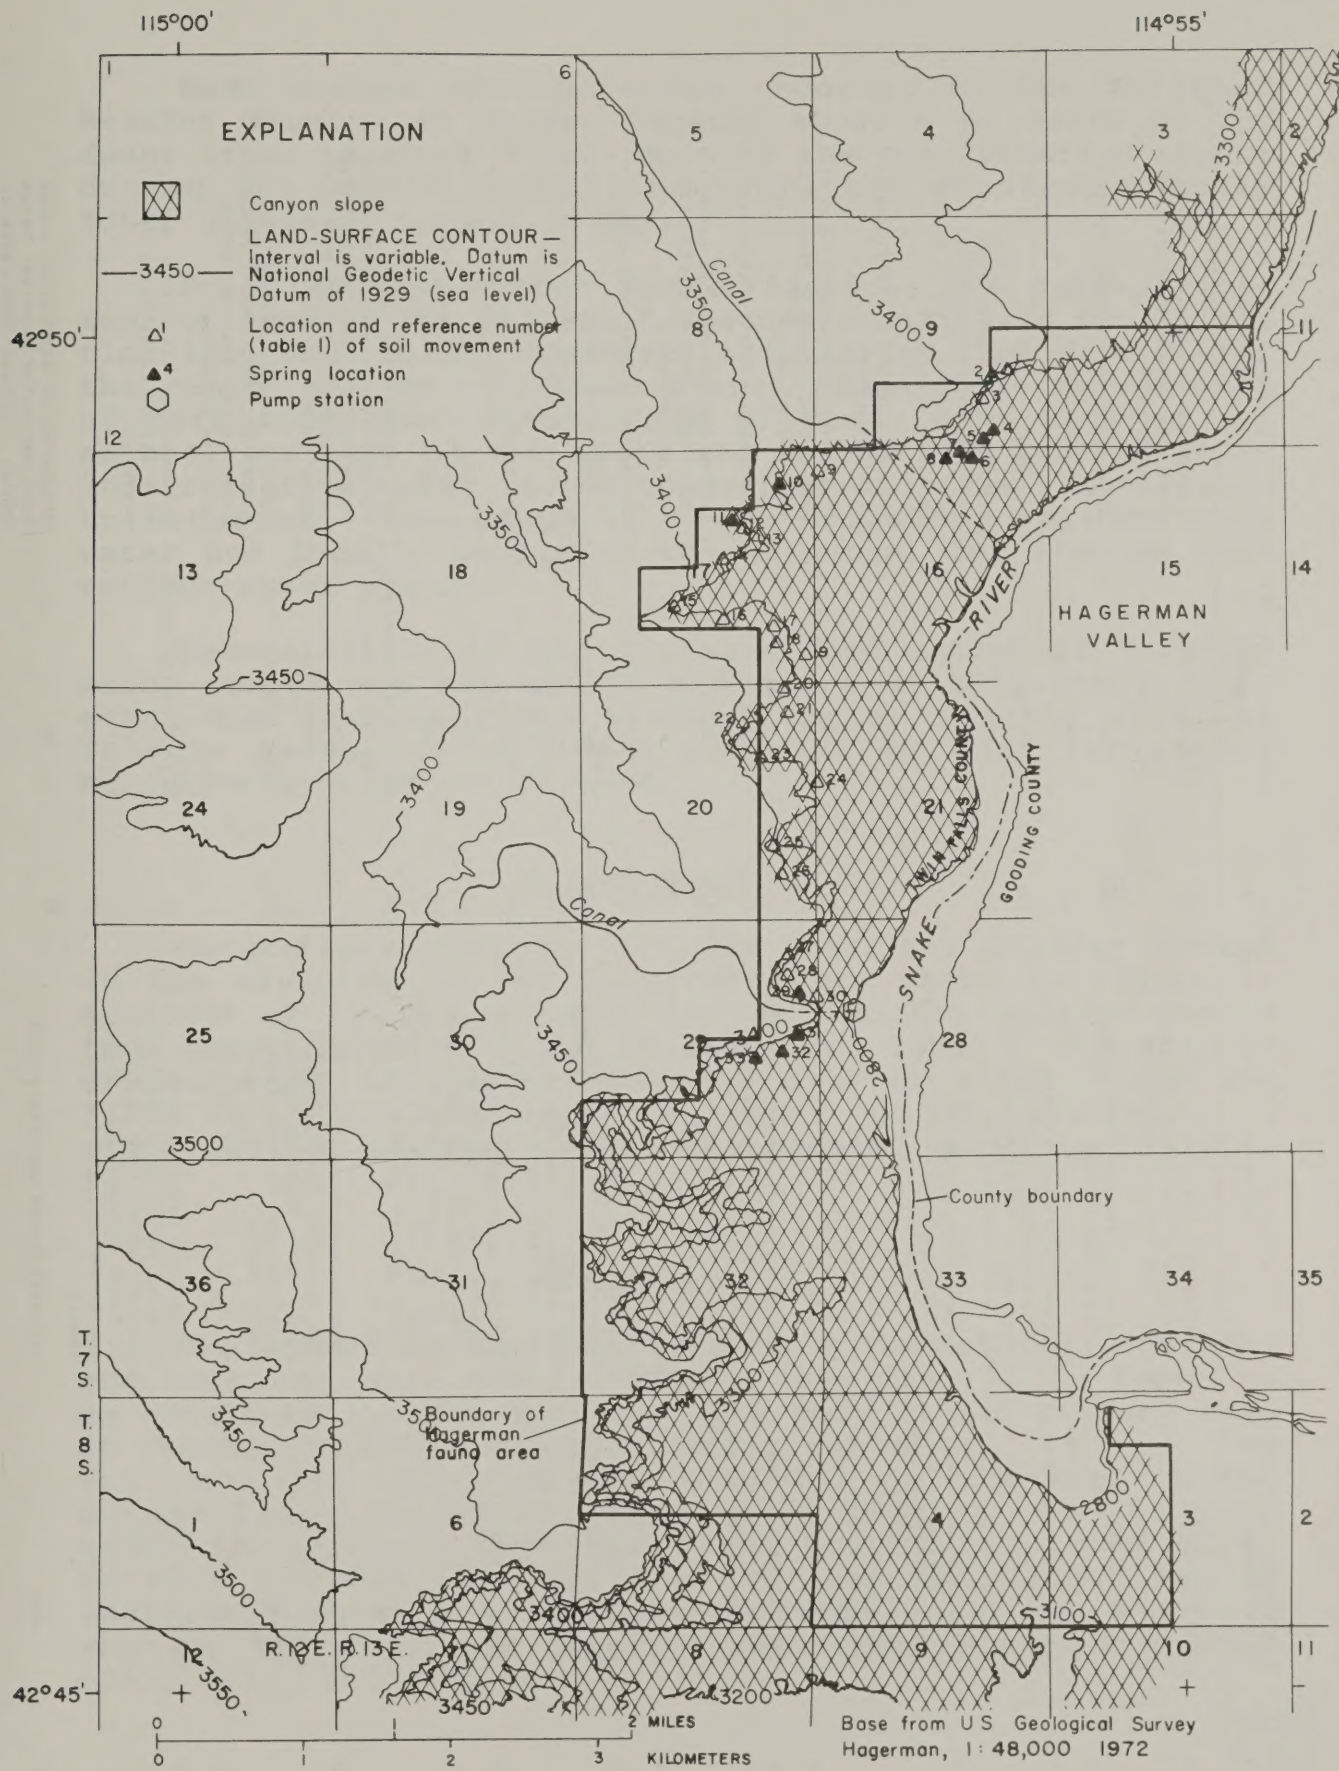
Figure 4.--Sites of major soil movement.

Soil movement in the fauna area is the result of erosion from surface-water runoff and ground-water discharge from springs and seeps. Presently, 22 sites have been affected by surface-water runoff and 11 sites have been affected by ground-water discharge. Sites of major soil movement are shown in figure 4, and descriptions and probable cause(s) are given in table 1.

Table 1.--Description and causes of soil movement

Site number (location shown in fig. 4)	Description of soil movement	Cause(s) of soil movement	Site number (location shown in fig. 4)	Description of soil movement	Cause(s) of soil movement
1	Gully erosion	Irrigation runoff. Broken mainline in sprinkler system; pipe has been repaired	14	Gully erosion	Irrigation and natural runoff. Powerline access road acts as a collector
2	do.	Natural drainage. Irrigation and natural runoff	15	do.	Irrigation and natural runoff
3	Gully erosion, large washouts	Irrigation runoff. Most erosion occurs when valve in main sprinkler line is opened to flush system	16	do.	Do.
4	Soil slump or creep below springs. Soil creep has filled natural channel. Springs have cut new channels through slumping material	Ground-water discharge. Springs have saturated material below vents	17	do.	Do.
5	do.	Do.	18	do.	Irrigation runoff. Most erosion occurs when valve in main sprinkler line is opened to flush system

6	Soil slump or creep below spring, gully erosion below spring	Ground-water discharge. Spring has saturated material below basalt outcrop. Some gully erosion below spring due to surface-water runoff	19	do.	Natural runoff, possibly some irrigation runoff
7	do.	Do.	20	do.	Irrigation and natural runoff; access road to Snake River acts as a collector
8	Soil slump or creep below springs. Large gully erosion below springs	Ground-water discharge. Springs have saturated material below basalt outcrop. Most of the large gullies due to surface-water runoff	21	do.	Irrigation and natural runoff
9	Gully erosion	Irrigation runoff. Most erosion occurs when valve in main sprinkler line is opened to flush system. A pipe under road collects irrigation runoff, which adds to surface-water runoff	22	do.	Irrigation and natural runoff; road along edge of field acts as a collector
10	Soil slump or creep below spring, some gully erosion below spring	Ground-water discharge. Spring has saturated material below vent. Some movement due to gully erosion from surface-water runoff	23	do.	Irrigation and natural runoff

11	do.	Do.	24	do.	Do.
12	Gully erosion	Irrigation runoff. Most erosion occurs when valve in main sprinkler line is opened to flush system. Some erosion due to natural and irrigation runoff	25	do.	Do.
13	do.	Irrigation and natural runoff	26	do.	Do.
			27	do.	Do.
			28	do.	Do.
			29	Soil slump or creep; some gully erosion	Ground-water discharge. Springs have saturated material below vents. Some movement due to gully erosion from surface-water runoff
			30	Gully erosion	Natural runoff; probably enhanced by roads around communication relay station, which act as a collector
			31	Soil slump or creep	Ground-water discharge; seeps have saturated material below vents
			32	do.	Do.
			33	do.	Ground-water discharge; seeps have saturated material below vents. Leakage from valve in sprinkler line may add to saturation of material near slump

1. Lining or otherwise treating the two irrigation canals to reduce seepage losses would eliminate the principal source of recharge to the perched aquifer.
2. Eliminating the practice of flushing irrigation sprinkler systems adjacent to the canyon rim would halt the severe erosion in areas below the valves.
3. Constructing berms and cross dips on all roads in and adjacent to the fauna area would reduce the rate of erosion from surface-water runoff.

4. Establishing an uncultivated strip of land between irrigated farmland and the canyon rim would reduce the amount of surface-water runoff and hence reduce soil erosion.

Implementing corrective measure 1 would reduce soil movement that is the result of ground-water discharge at 11 sites. Implementing corrective measures 2, 3, and 4 would reduce soil movement that is the result of surface-water runoff at 22 sites.
